GENERAL DYNAMICS
ASTRONAUTICS

COMPILATION OF

Fourth Quarterly Progress Report - Phase I 1 March 1963 to 27 May 1963

Interpretation of Radiographic Images of Nickel Foil Reinforced Resistance Spot Welds in Type 301 Stainless Steel

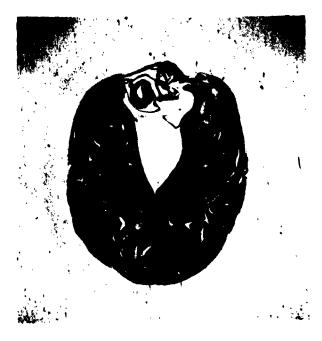
Figure 6. Photomicrograph (30X) of a plan view of spot weld No. 6 shown in Figure 5. This is a view of the weld nugget in its entire shape and represents an intermediate stage between the ring weld and a complete nugget. Note that the X-ray image represented the true outline of the weld nugget.
